# Seismic retro-fit of an historic earth dam using grouted stone columns

D. Avalor<sup>1</sup>, B. Kok<sup>2</sup>, and T. Lennie<sup>3</sup>

Toorourrong Reservoir was constructed in 1885 to collect water from the Plenty River and the Wallaby Creek and Silver Creek Aqueduct systems at a point north of Whittlesea, Victoria, and to divert this water into the Clear Water Channel for transfer to Yan Yean Reservoir. The reservoir is located approximately 35km north-east of Melbourne city centre.

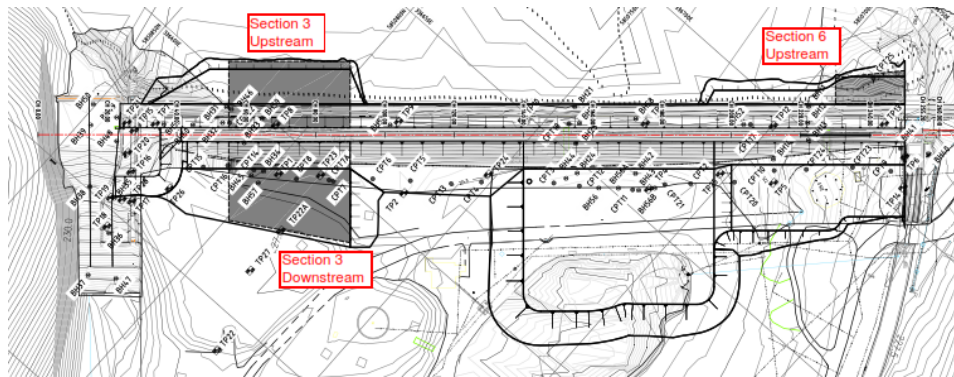
Fig. 1 Layout Plan of Geotechnical Investigation Locations and Remedial Sections

There are layers and zones of potentially liquefiable soils within some of the soil units. On the basis of the geological conditions and back-analysis of stability and long-term performance of the dam, a significant risk of liquefaction under earthquake loading and possible subsequent slope failure was identified at two cross-sections along the dam alignment. Three areas, as shown in Figure 1, were identified for remedial work to reduce the risk to an acceptable level.

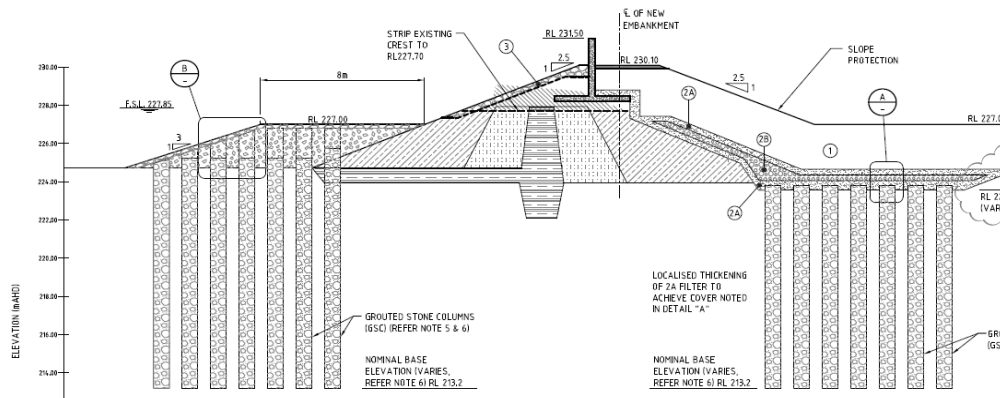
Fig. 2: Section 3 Treatment and Construction Cross-Section

Section 3 is located towards the west abutment and the spillway and is the location of the former course of the Plenty River before construction of the dam. The geometry of the foundation soils at Section 3 was idealised to four main layers (Units T1, T2, T4, T5) and a downstream lens T3. Units T2, T3 and T4 are the potentially liquefiable layers in this section.

Factors of Safety (FOS) as low as 1.0 were computed for some slip surfaces in Sections 3 and 6 (WRA 2010b). The remedial zone was analysed as a soil block and the ground treatment was applied to achieve a minimum FOS of 1.2 for slope stability under post-liquefied ground conditions. The GSCs adopted for this project comprise 0.8m diameter columns constructed on a 1.7m triangular grid pattern. Column depths varied dependent on the depth of the weak soils and the shape of the failure surface. The diameter and spacing represents a replacement ratio of approximately 20%, which is within normal range for vibro (grouted) stone columns. The remedial work at Section 3 is shown in Figure 2.

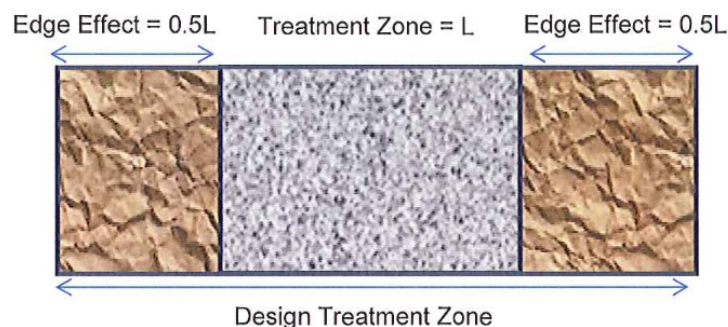
Fig. 3 – Treatment Block Width Adopted for Design

The US Army Corps of Engineers method was adopted to define the treatment zone under a ‘conventional’ application, which extended it outside the perimeter by a distance of at least half the width of the treatment zone (see Figure 3).

The results indicated that the columns, particularly the first two rows, were incapable of restraining such a large differential strain. The maximum calculated displacements of 55mm to 90mm represented failure strains of 6.9% to 10.9%. This confirmed the requirement for the extended treatment block width as shown in Figure 3.

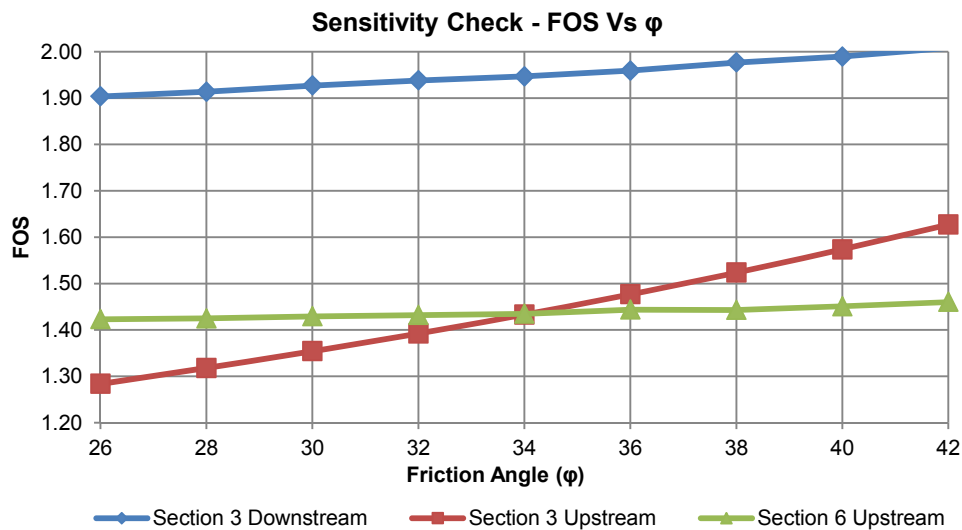
Fig. 4 – Sensitivity check of friction angle against factor of safety

A sensitivity check on a range of the design friction angle ( $\phi$ 'd) against slope stability FOS achieved from the limit equilibrium method are presented in Figure 4, demonstrating the adequacy of the proposed soil block dimensions. Different failure modes were assessed to ensure the selected models were within the safety zone for the case where the soils surrounding the columns within the soil block were not liquefied. The FOS obtained for composite internal friction angles of the soil block between  $28^\circ$  to  $40^\circ$  exceeded the required value of 1.2.

Concern was expressed that the introduction of bentonite into the grout mix could reduce the internal friction angle of the column significantly; this sensitivity check aimed to mitigate the design risk ensuring the proposed soil block was safe within the proposed range of design phi angle ( $\phi$ 'd).

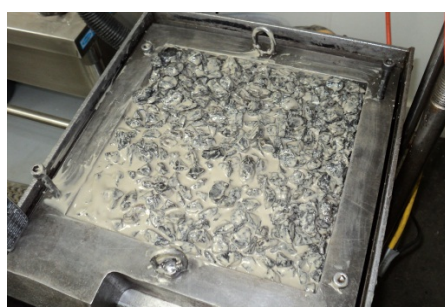
Fig. 6: Shear Box Test on Grouted Stone

As is evident, the friction angle of the stone was generally between 50° and 60° and slightly higher after curing of the grout. The results show little effect from the inclusion of bentonite in the slurry, a critical factor in the design analysis, where a friction angle of between 28° to 40° was calculated.

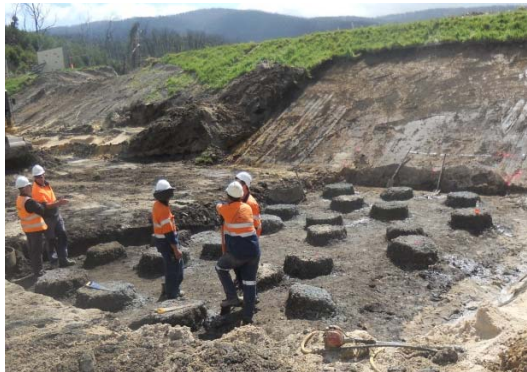
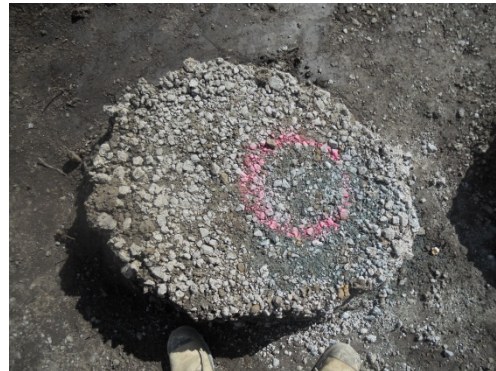
Trial columns were installed in the area of Section 3 Downstream during the first phase of the three phases of work. These are shown in Figures 8a and 8b with their tops exposed.
