TECHNIQUES FOR REDUCING RISK AND INCREASING SAFETY FROM ROCKFALLS IN OPEN MINES IN AUSTRALIA

[1]Jeroen Berends, *Maccaferri Australia Pty Ltd, 22 Seven Hills – Sydney, Australia*
[2]Dale Chaychuk, *Geofabrics Australasia Pty Ltd,Malaga, Perth, Western Australia, Australia*
[3]Giorgio Giacchetti, *Officine Maccaferri Spa, Zola Predosa, Bologna, Italia*

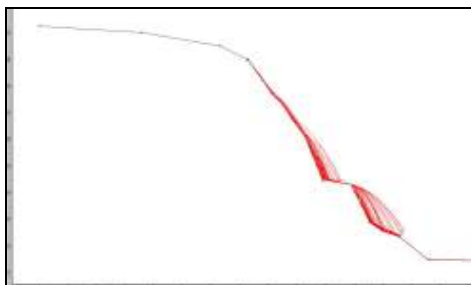
Figure 4. Rock fall simulation

Rockfall simulation (Figure 4) was performed using Rocscience's Rocfall software. The methodology adopts a representative design boulder chosen from an assessment of actual rock measurements. In order to model a realistic simulation, the restitution coefficients needed in the software were empirically adjusted until the boulder arrest points were similar to those observed from the historic rock scatter records. The trajectory analysis was performed with 2000 detachment releases in order to obtain statistically significant results. At the selected location for the barrier, the results indicated that 95% of rocks would have bounce heights less than 3m and velocities lower than 18m/s, suggesting the requirement for a barrier capable of absorbing impacts with energies of approximately 250kJ (Figure 4). The required energy level of the rockfall barrier was calculated using the general equation:

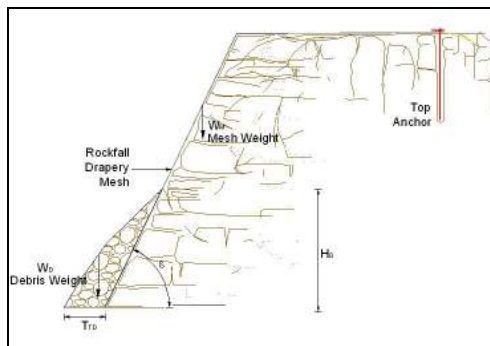
Figure 10. Conceptualisation of a drapery system

mesh at the foot of the cutting before routine maintenance cleared the debris in a controlled manner. The allowable debris accumulation width at the base was taken as 1m (measured horizontally). 1m was taken as the limit, because any additional accumulation would start to impose on the rail corridor. Meanwhile, the maximum debris accumulation height was taken as 3m (measured vertically). In calculating the accumulated debris weight (W_D), factors taken into account include the mesh weight (W_m), slope height, slope inclination (β) and the friction angle between the debris and the slope (Figure 10).
